1. REPORT D		2. REPORT T Viewgraphs		3. DATES COV	
4. TITLE AND	SUBTITLE	1		5a. CONTRACT	T NUMBER
Ultrasonic Ima	ging of TTCP Sam	ples		5b. GRANT NUMBER 5c. PROGRAM ELEMENT NUMBER

# The Technical Cooperation Program (TTCP)

Evaluation of Samples Using Ultrasound Imaging Dr. Ignacio Perez William R. Davis

16 - 20 October 2000

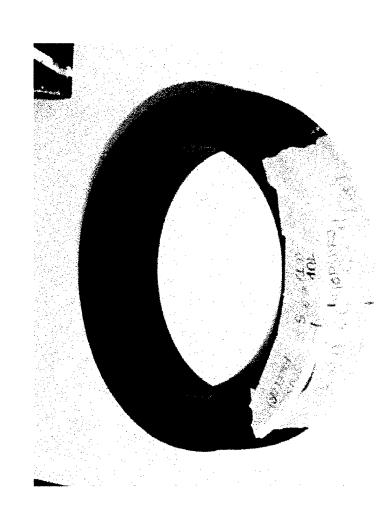
# RAH 66 Quill Shaft 7/8" thick by 6" dia. By 1 1/8" high ring.

1/8" high ring. A 1 MHz 1.5" diameter transducer was RAH 66 Quill Shaft is a 7/8" thick by 6" diameter by 1 used in through transmission mode. This shows a full height disbond 1/2" wide.

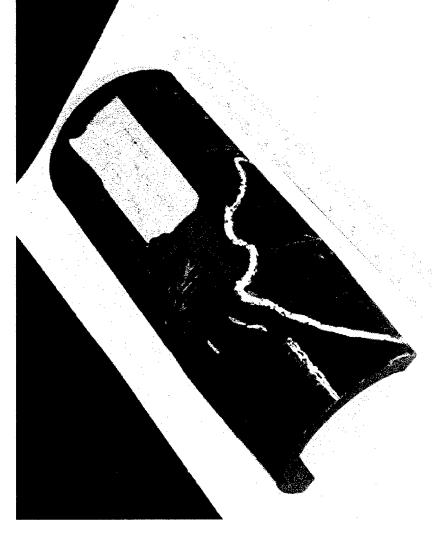
transmission. Thickness is 1/2 inch to 1 inch. Height 12.5 inch, RAH66 Quill Detector Face (Dr) Shaft Examined by through 5 3/4 inch diameter

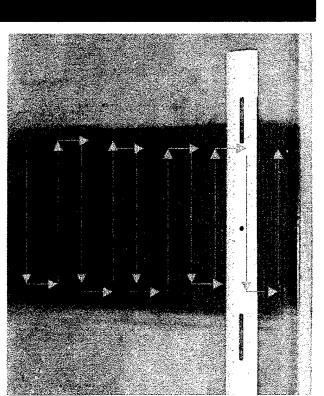
using 5 MHz ultrasonic reflection camera in reflection 3 cm thick balsa wood cored multilayer panel imaged
